Akutan and Nikolski

Get Water Treatment Projects

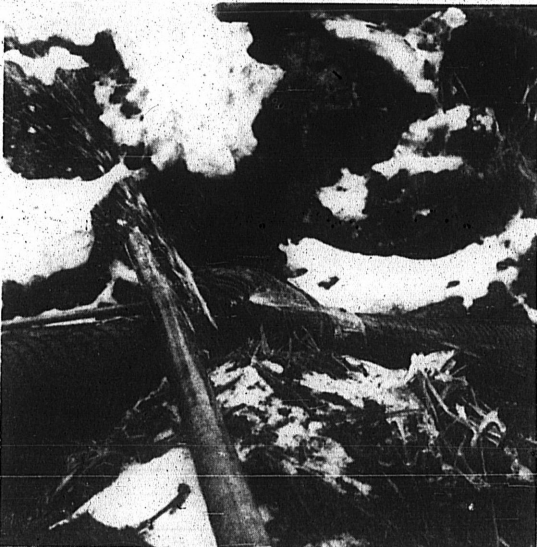
The old water system shows faults where it is leaking after an effort had been made to repair it. (Akutan)
